# CONTAINER LOADING REPORT

| Service Performed: | Container Loading Supervision |
| Loading Location: | Jinhua City, Zhejiang Province, China |

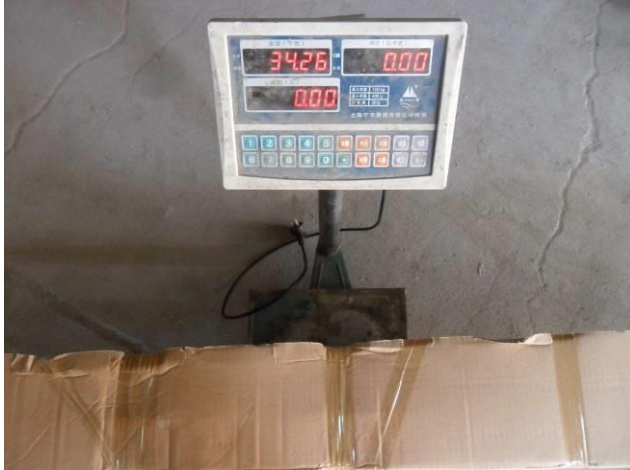
Gross weight check

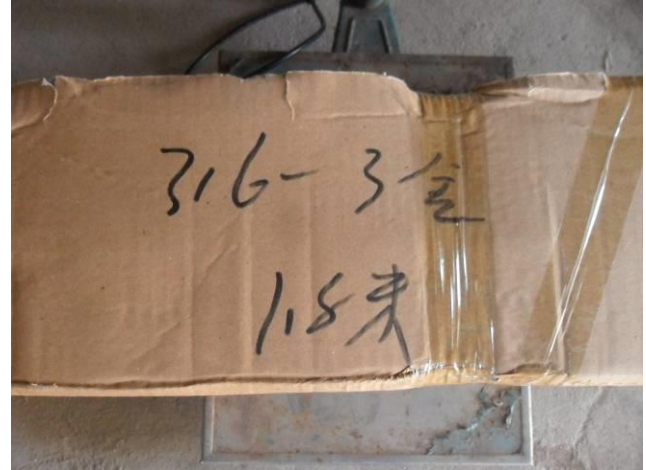
Marking on carton

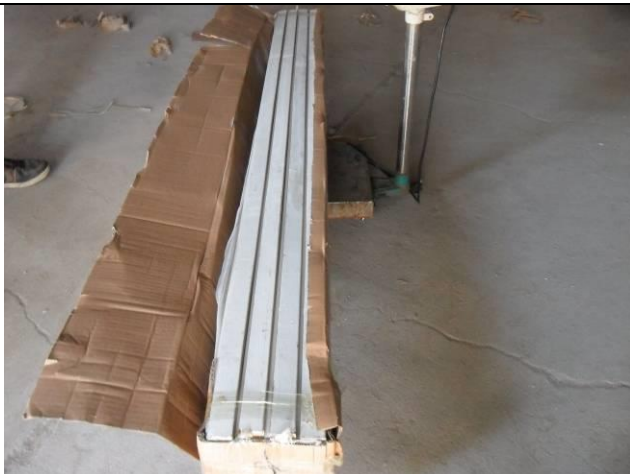
Unit packing

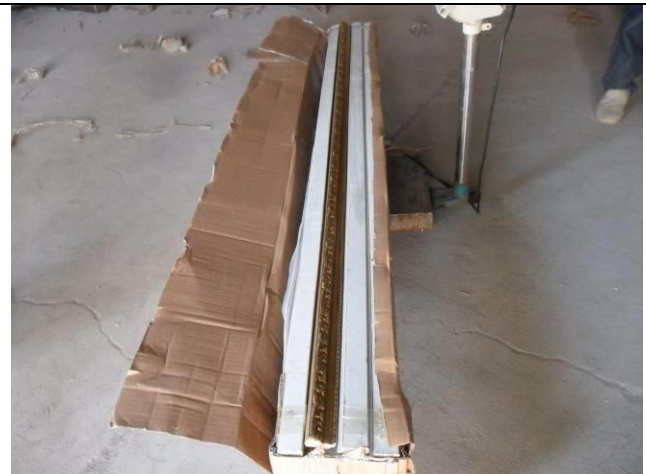
Unit check

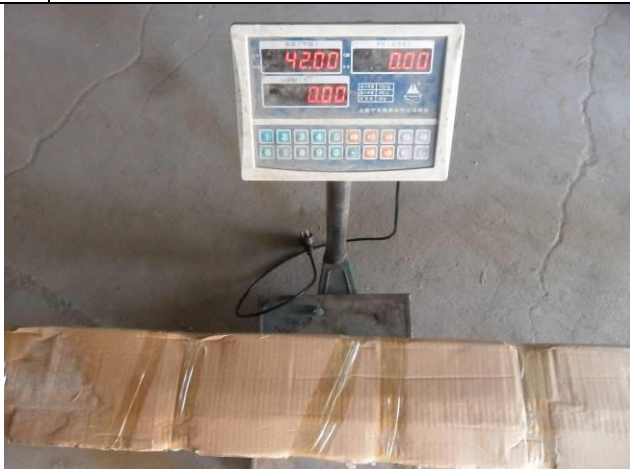
Gross weight check

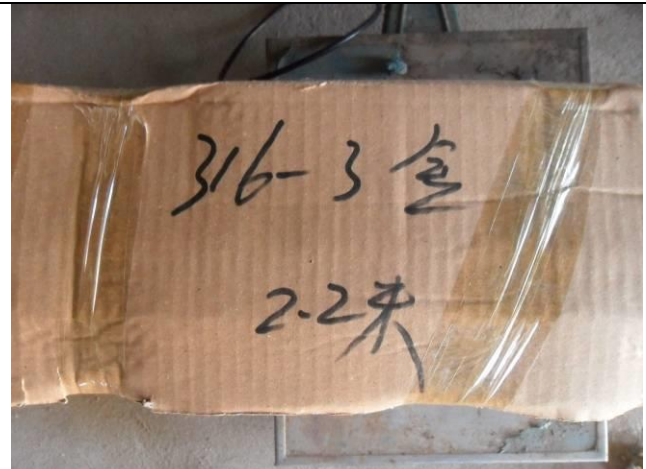
Marking on carton

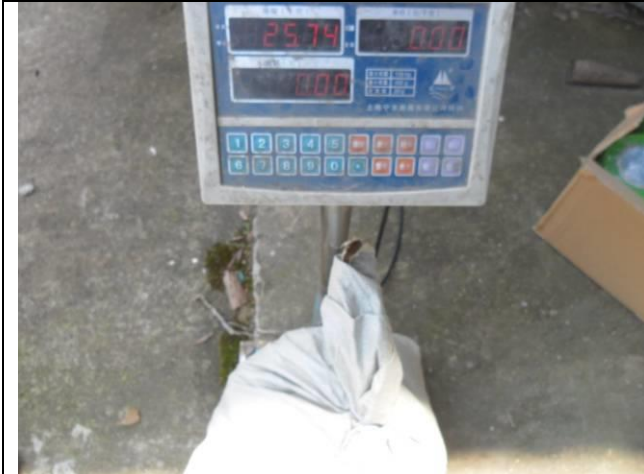
| 2. | There were 5 cartons tape and 1 carton metal units, which were not list in packing list loaded into container. |

Gross weight check

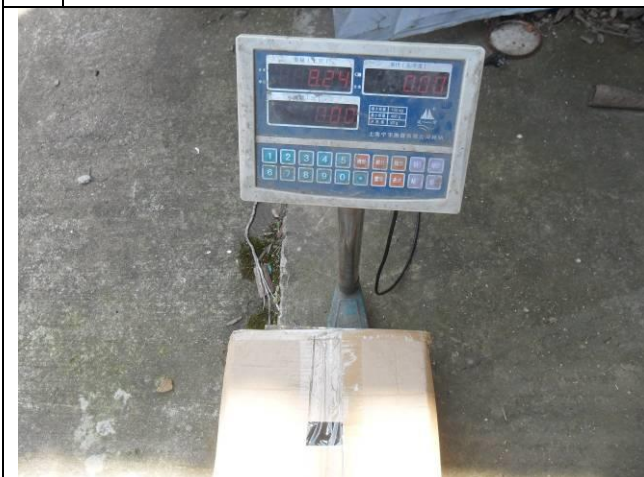
Gross weight check

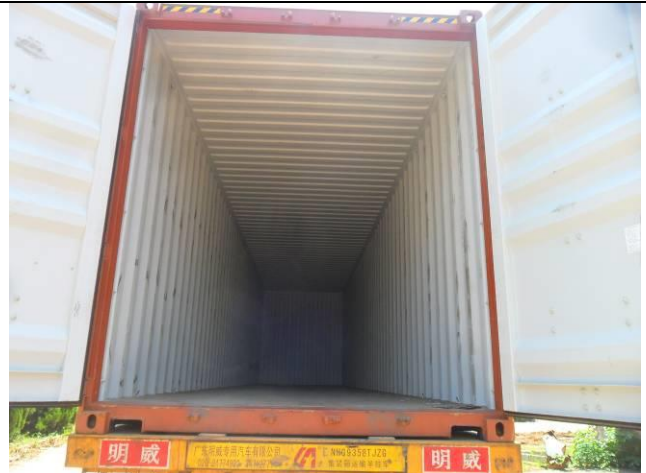
Empty container

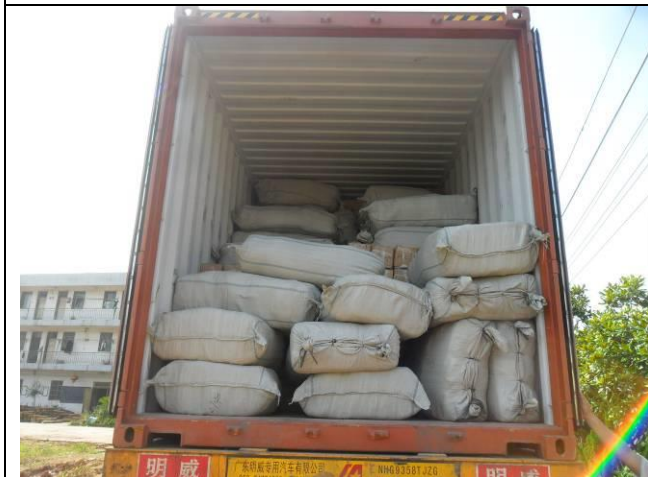
| 1. | The actual loaded quantity was 598 cartons, different from client's packing list 709 cartons. Please refer to attached packing list and section A for details. |

Full loading

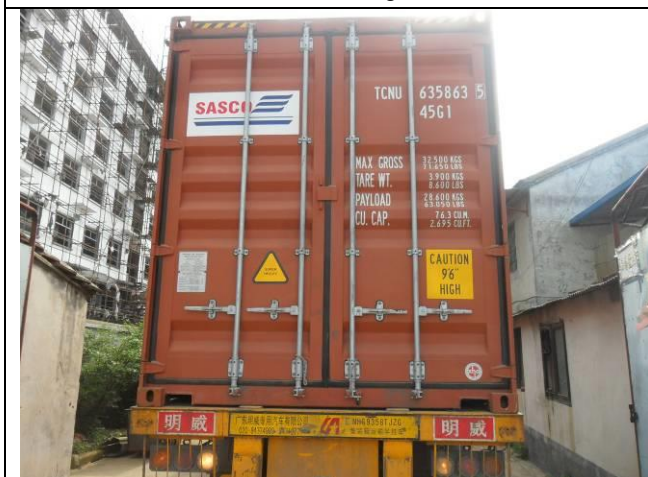
| 3. | The container had been sealed on site. |

Close-up of sealed
