## ONLINE INSPECTION REPORT

| GENERAL INFORMATION | | PRODUCT PHOTO |
|---|---|---|
| Project number | BrM355268 _2004 | |
| Description of product | Oral Irrigator | |
| Supplier | Zhongshan Sunpower Smart Home Electrical Company Ltd | |

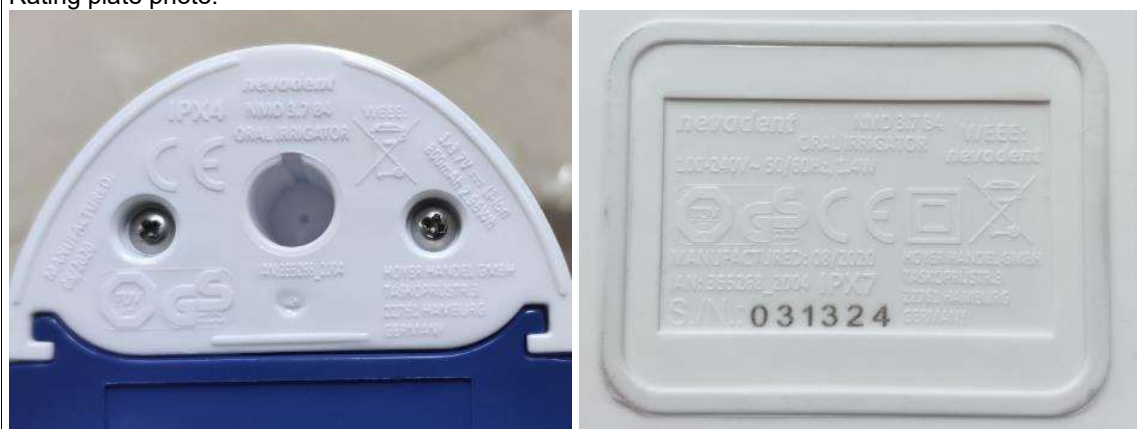
Rating plate photo:

| RATING PLATE | | <input checked="" type="checkbox"/> PASS | <input type="checkbox"/> FAIL | <input type="checkbox"/> N/A |
|---|---|---|---|---|
| a, | CE symbol (height min.5mm), GS logo (UK/CH plug no GS ) | <input checked="" type="checkbox"/> | <input type="checkbox"/> | <input type="checkbox"/> |
| b, | Trademark as per approved artwork | <input checked="" type="checkbox"/> | <input type="checkbox"/> | <input type="checkbox"/> |
| c, | Technical parameters (Voltage, Wattage, IP...), refer to certificate/CDF | <input checked="" type="checkbox"/> | <input type="checkbox"/> | <input type="checkbox"/> |
| d, | WEEE mark (with underline, height min 7mm) | <input checked="" type="checkbox"/> | <input type="checkbox"/> | <input type="checkbox"/> |

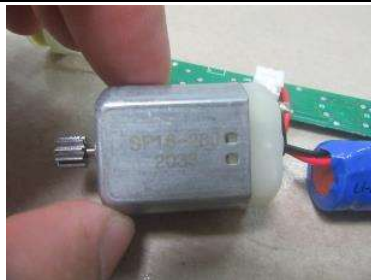
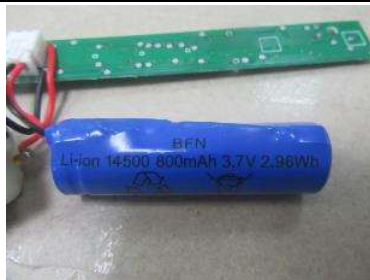
| COMPONENTS CHECK- CDF | | | <input checked="" type="checkbox"/> PASS | <input type="checkbox"/> FAIL | <input type="checkbox"/> N/A |
|---|---|---|---|---|---|
| Motor (water pump): SP16-280 DC3.7V | Battery: Li-ion 14500 800mAh 3.7V 2.96Wh | PCB: FR-4 94V-0 | | | |
| Internal wire: E314089 1007 24AWG BOYU | Power cord: TIAN JU H03VVH2-F 2X0.75mm | Power plug: TIAN JU TJ-005 250V 2.5A | | | |

| Base PCB: KB-3151C 94V-0 | X2 capacitor: QINHONG MPX 0.22uF 275V 40/110/56/B | Varistor: QNB 07D471K VDE |
| Thermal link: C9 102°C 1A 250V | N/A | N/A |

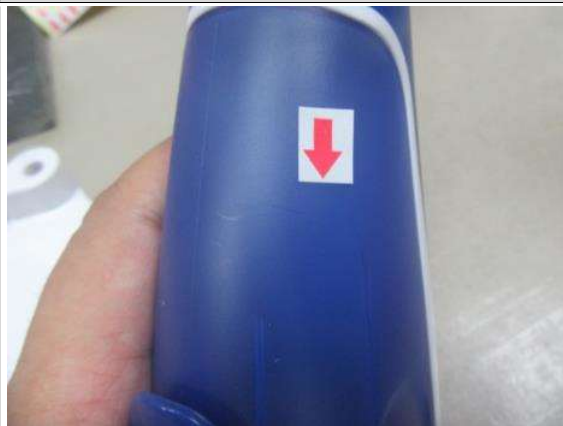
PHOTO OF DEFECTIVES

| TECHNICAL DATA | | | | | |
|---|---|---|---|---|---|
| Remarks:<br>1 of 5 main unit has a relatively short discharge time, and the working current is too large due to the motor fault. | | | | | |

Scratch mark -2pcs

Mixed color -1pc

Glue mark -1pc

Poor painting of control panel -2pcs

1 of 5 main unit has a relatively short discharge time, and the working current is too large due to the motor fault.

| QUALITY STATUS (summary of found defectives) | | | | | |
|---|---|---|---|---|---|
| 1 | Scratch mark -2pcs | We had requested factory to enhance check | | | |

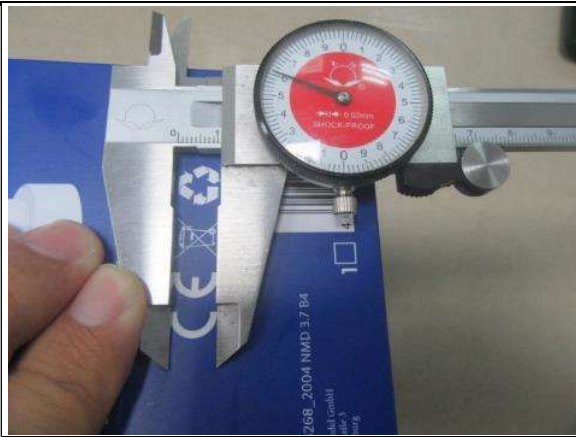
CE mark height: min 5mm

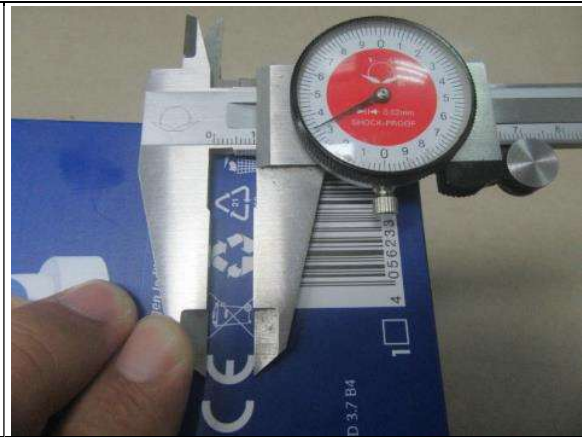
WEEE mark height: min 7mm

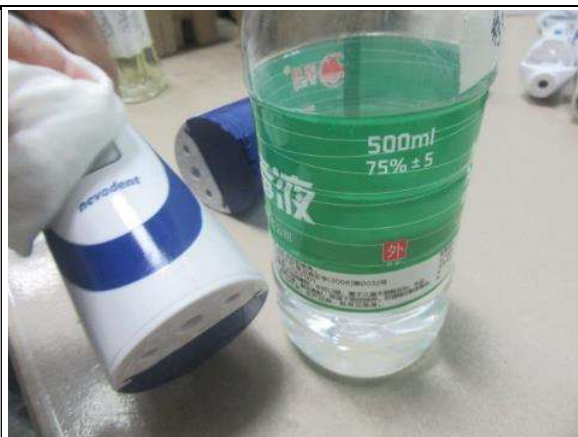
Rubbing test with 75% alcohol

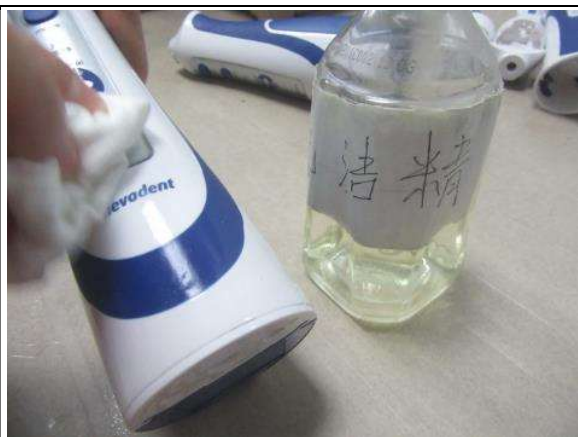
Rubbing test with washing-up liquid

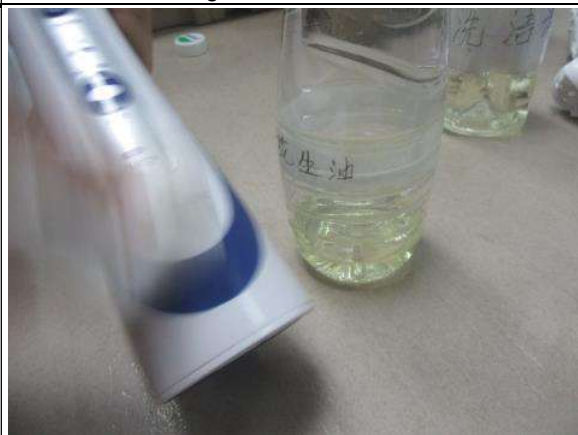
Rubbing test with vegetable oil

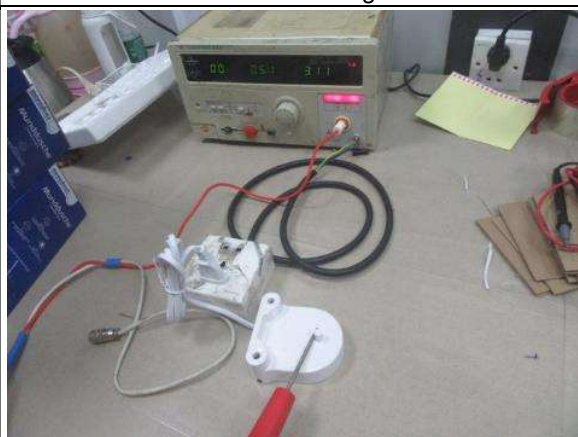
Hi-pot test

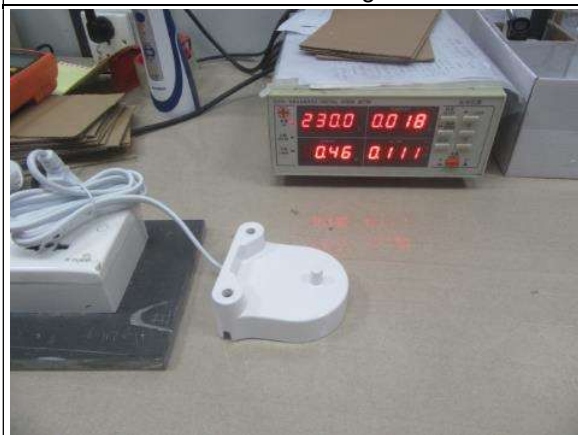
| TECHNICAL DATA | | | | | |
|---|---|---|---|---|---|
| Charging station standby power<br>(<0.5 W) | 0.46 | 0.45 | 0.45 | 0.48 | 0.44 |

Charger base standby power (<0.5W)

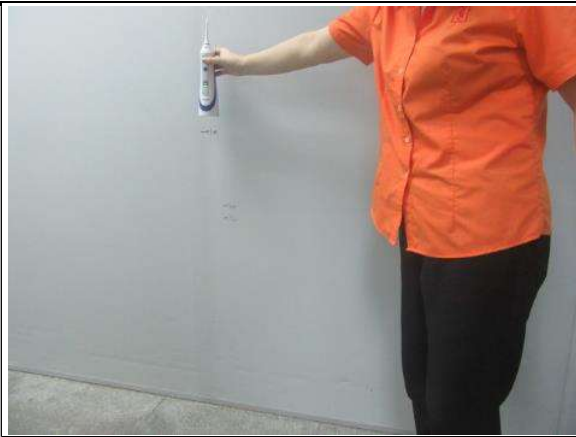
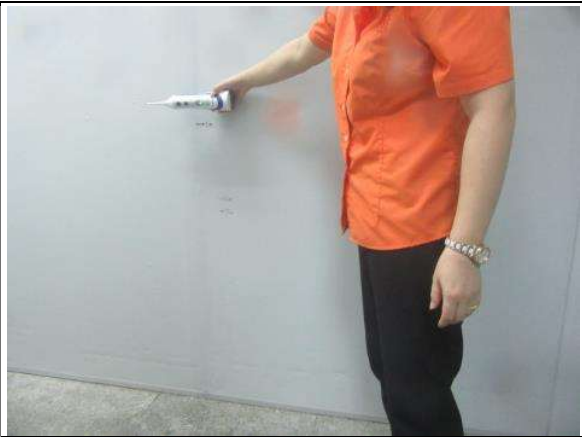
| TECHNICAL DATA | | | | | |
|---|---|---|---|---|---|
| Main unit drop test-100cm/2 times | P | P | P | / | / |

Unit drop test at 100cm

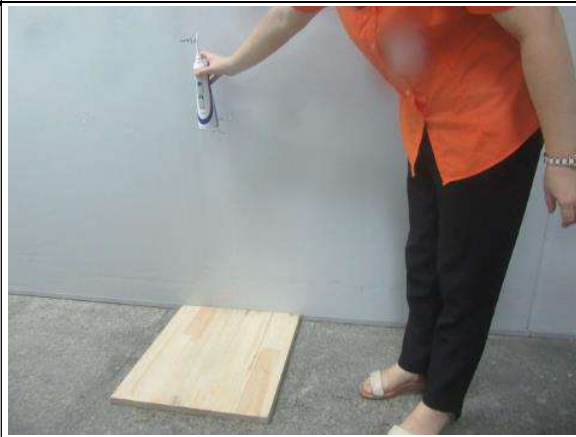
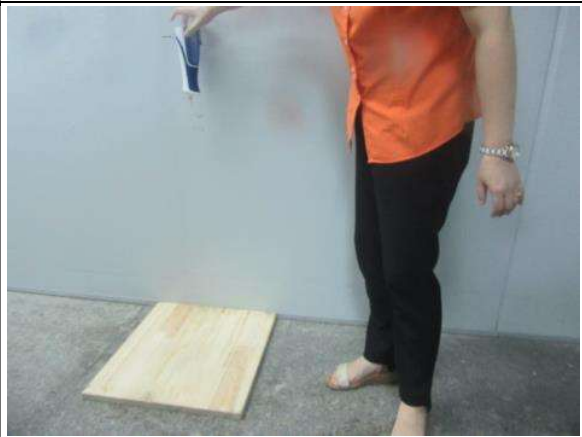
| TECHNICAL DATA | | | | | |
|---|---|---|---|---|---|
| Main unit drop test-70cm/5 times | P | P | P | / | / |

Unit drop test at 70cm

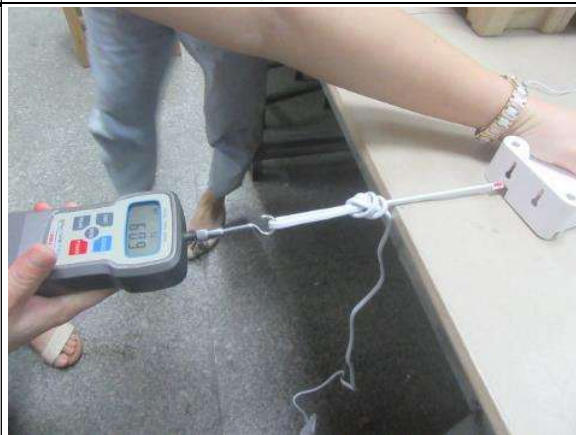
| TECHNICAL DATA | | | | | |
|---|---|---|---|---|---|
| Pull force test for the power cord<br>inlet (60N) | P | P | P | P | P |

Charging station cord pull test

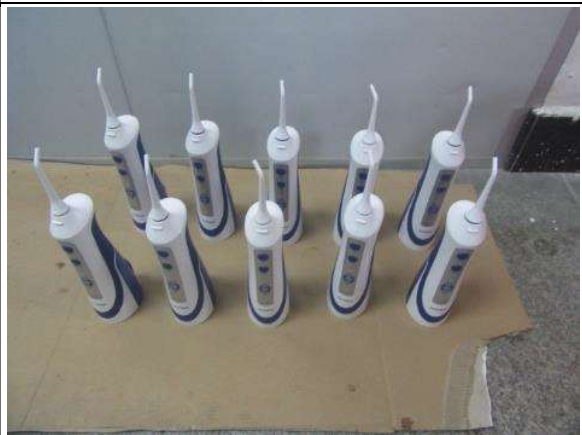
| TECHNICAL DATA | | | | | |
|---|---|---|---|---|---|
| Leakage test of water tank | P | P | P | P | P |

Leakage test of water tank

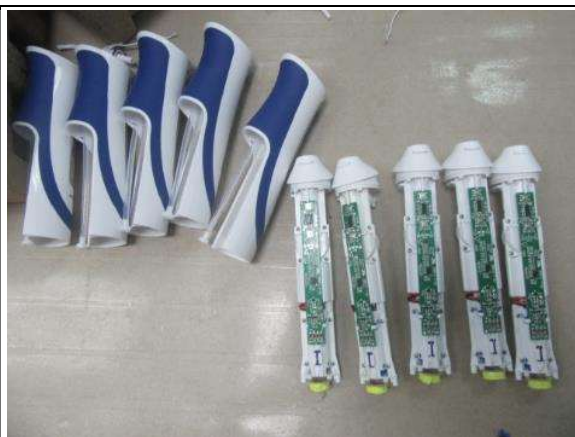
| TECHNICAL DATA | | | | | |
|---|---|---|---|---|---|
| Waterproof test 10min | P | P | P | P | P |

Internal check after 10 mins water proof test

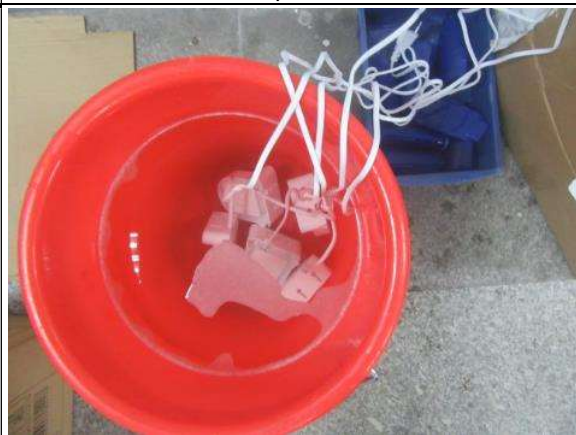
| TECHNICAL DATA | | | | | |
|---|---|---|---|---|---|
| IPX7 test (simple water immersion<br>test due to factory could not provide<br>1m depth container 4H) | P | P | P | P | P |

Charger IPX7 test (simple water immersion test)

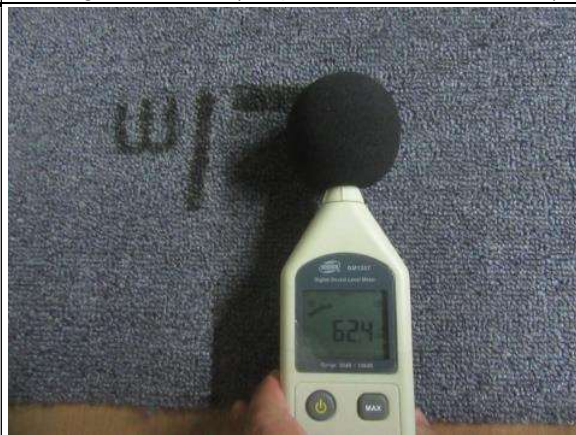
| TECHNICAL DATA | | | | | |
|---|---|---|---|---|---|
| Sound level at 1.0M Horizontal<br>(approx. 65 db for ref) | 58.9 | 58.6 | 61.0 | 59.5 | 60.2 |
| Sound level at 1.0M Vertical<br>(approx. 65 db for ref) | 62.4 | 61.8 | 59.9 | 59.5 | 59.6 |

Sound level check
