**Report No.: 4903920.00-15**
**Report Date:** xxxxxx

## Inspection report

| Product Description: | 2 Persons Raclette Grill | | | | |
| Manufacturer Name: | Ningbo Weijie Electrical Appliance Co., Ltd. | | | | |

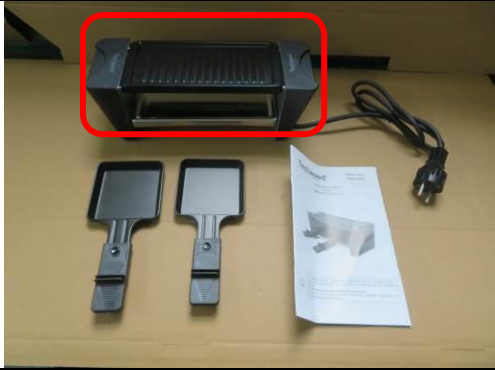
| | Please confirm | Status |
|---|---|---|
| 1 | <p>The actual product's baking plate is made of metal material, but it is described as baking stone in the actual instruction manual. (It's the same as the previous inspection report).</p> <div> </div> <div> <p>The actual product</p> <p>The actual instruction manual</p> </div> | Information |

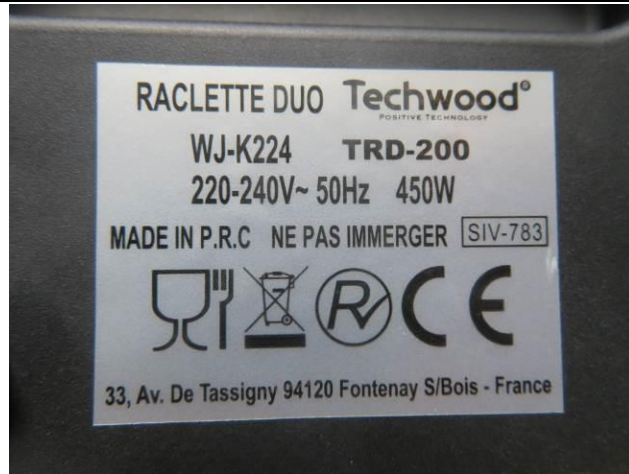
55) Rating label

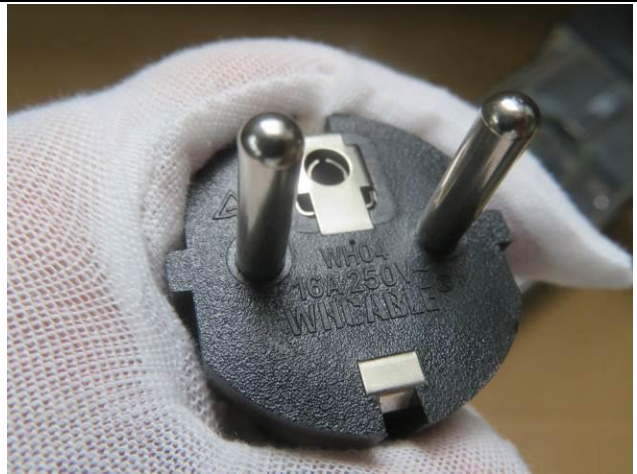
| | Component | Trade Mark | Model | Technical Data | Conformity Mark | Results |
|---|---|---|---|---|---|---|
| 1. | Plug | WEI HANG | WH-04 | 16A 250V | TUV R | Pass |

56) Plug

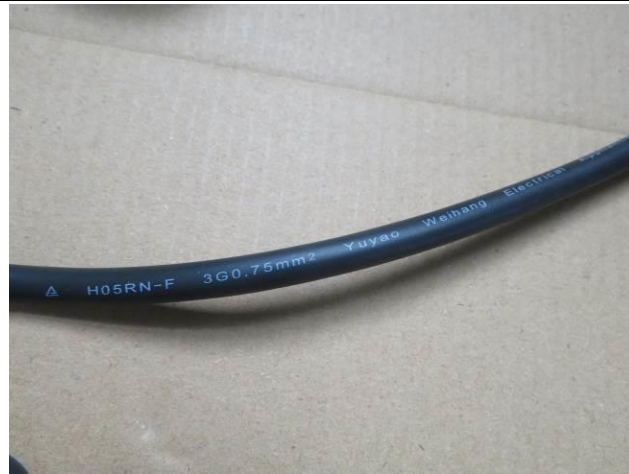
| | Component | Trade Mark | Model | Technical Data | Conformity Mark | Results |
|---|---|---|---|---|---|---|
| 2. | Power Cord | WEI HANG | H05RN-F | 3G0.75mm <sup>2</sup> | TUV R | Pass |

57) Power cord

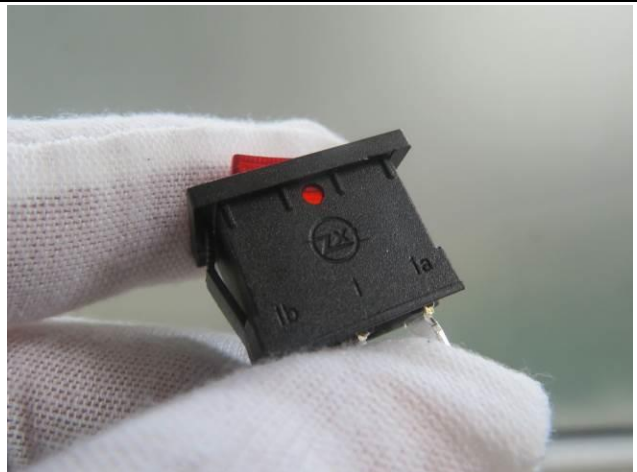
| | Component | Trade Mark | Model | Technical Data | Conformity Mark | Results |
|---|---|---|---|---|---|---|
| 3. | Switch | ZX | KCD1-B2 | 10(6)A 250V~ T105 | TUV R | Pass |

66) Switch

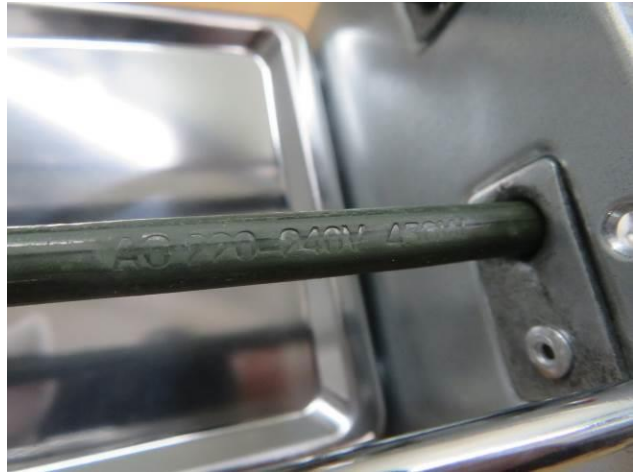
| | Component | Trade Mark | Model | Technical Data | Conformity Mark | Results |
|---|---|---|---|---|---|---|
| 4. | Heating element | Not identified | Not identified | 220-240V 450W | Tested with appliance | Pass |

68) Heating element

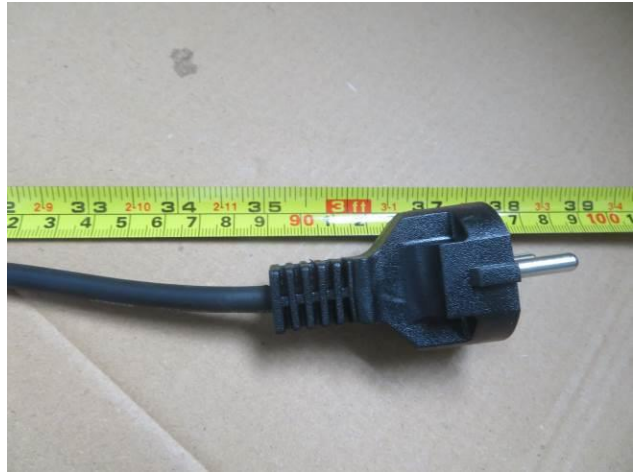
| Test performed | Sample size | Result | Comments |
|---|---|---|---|
| Power cord length measurement | 5 pcs | Pass | 88-89cm (Spec.: 80cm, not included plug) |

74) Power cord length

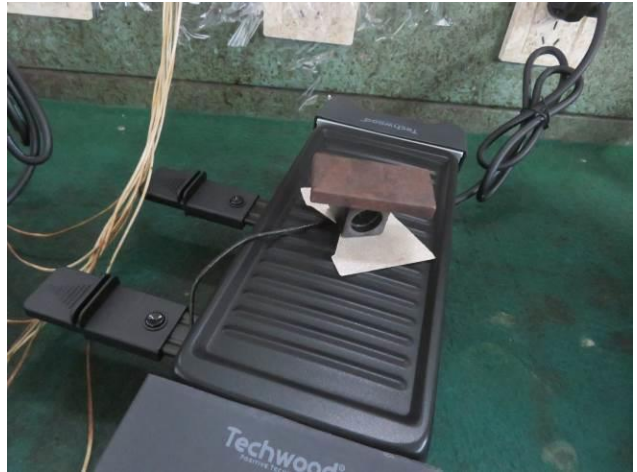
| Test performed | Sample size | Result | Comments |
|---|---|---|---|
| Temperature check at heating plate | 5 pcs | Reference | 221-247°C at 230V~ 50Hz (for reference only) |

76) Temperature measurement

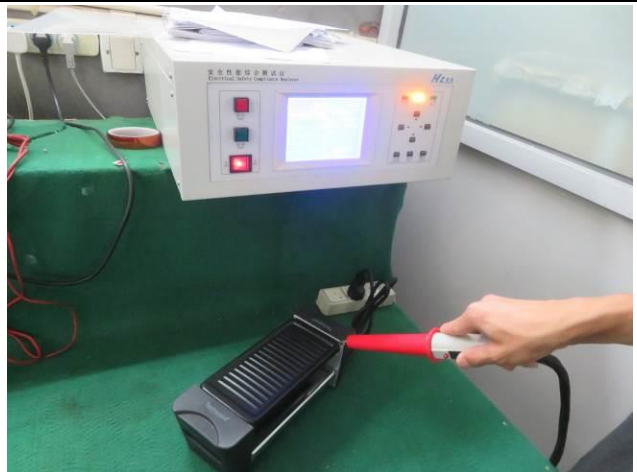
| Test performed | Sample size | Result | Comments |
|---|---|---|---|
| Hi-pot check | 125 pcs | Pass | 1,500Vac 5mA for 2sec, no breakdown |
| Earth resistance check | 125 pcs | Pass | 25A, R <= 0.1Ω |

78) Hi-pot check & Earth continuity check

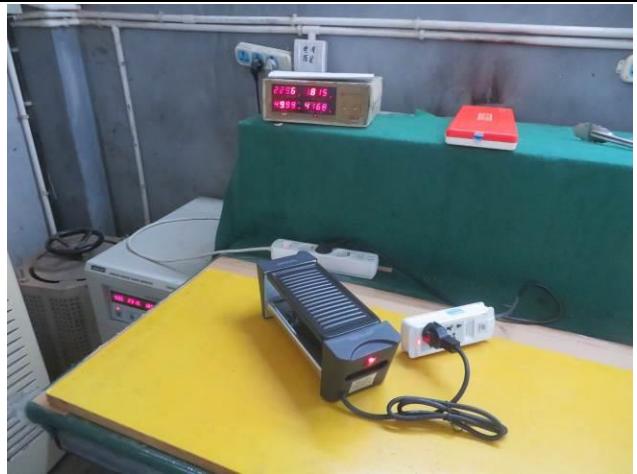
79) Hi-pot check & Earth continuity check

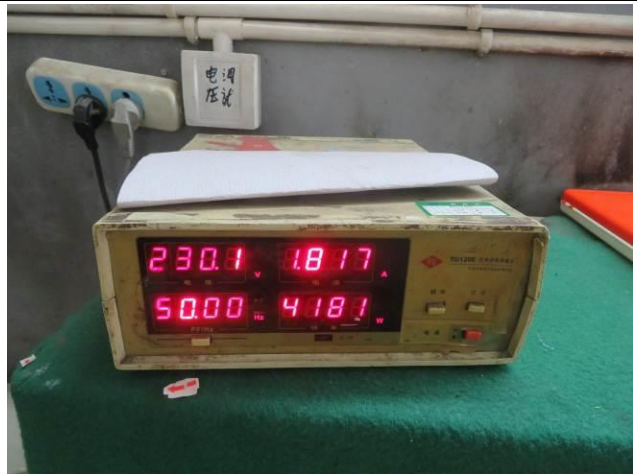
| Test performed | Sample size | Result | Comments |
|---|---|---|---|
| Input power consumption check | 20 pcs | Pass | 413-439W at 230V~ 50Hz |

81) Function check & Input power consumption

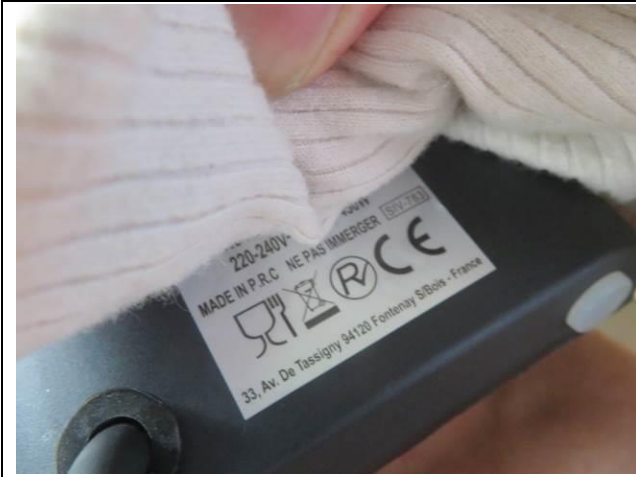
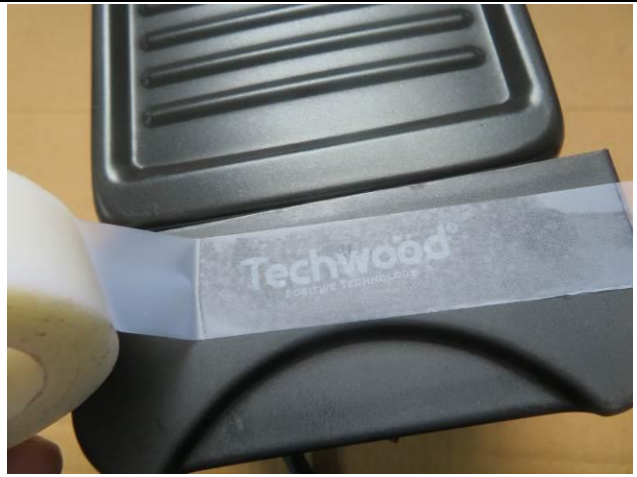
| Test performed | Sample size | Result | Comments |
|---|---|---|---|
| Rub check | 2 pcs | Pass | Rub 15s with water and then 15s with hexane |
| Tape check | 2 pcs | Pass | 3M 810# tape |

85) Rub check

86) Tape check

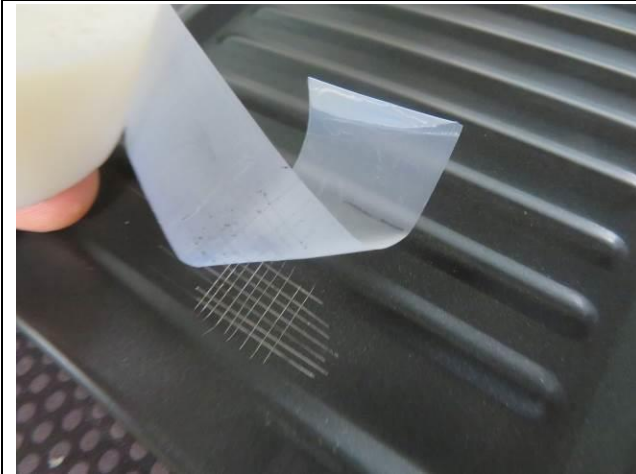
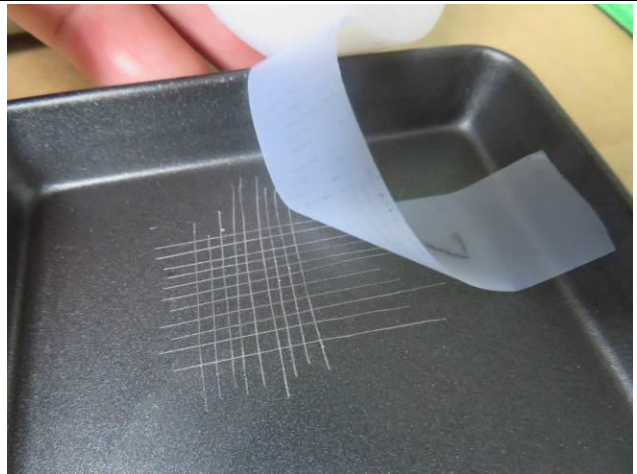
87) Coating adhesion check

88) Coating adhesion check

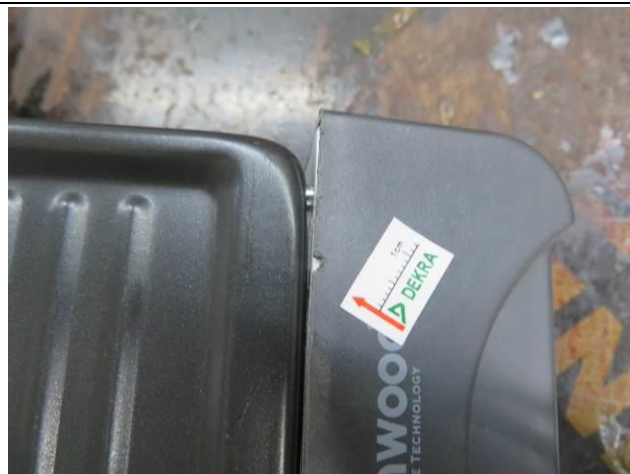
| - Chipped on product. | | | | 1 | |

95) Major - Chipped on product

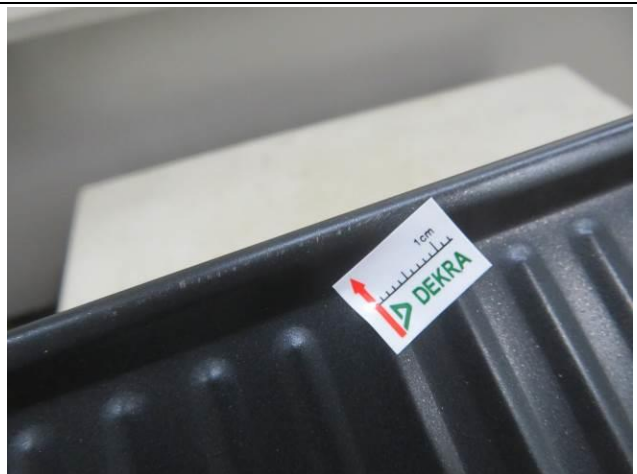
| - Scratch mark on heating plate. | | | | | 3 |

96) Minor - Scratch mark on heating plate

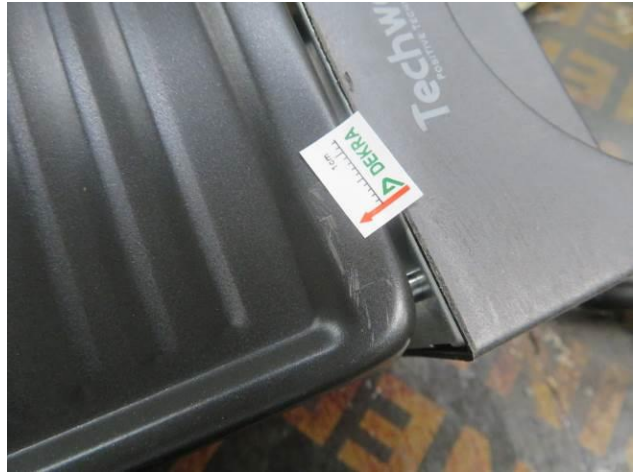
98) Minor - Scratch mark on heating plate

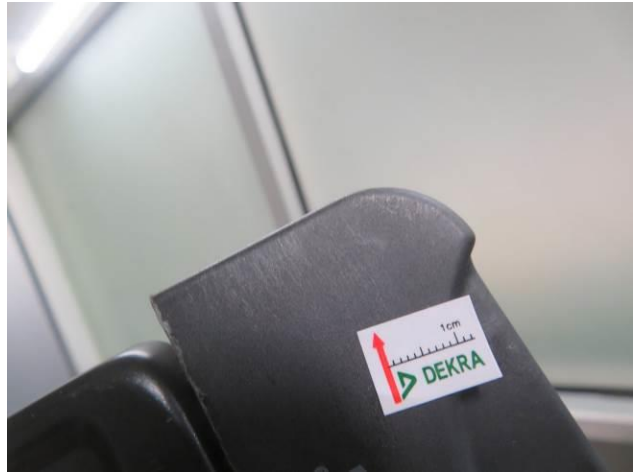
| - Flow mark on product. | | | | | 2 |

100) Minor - Flow mark on product

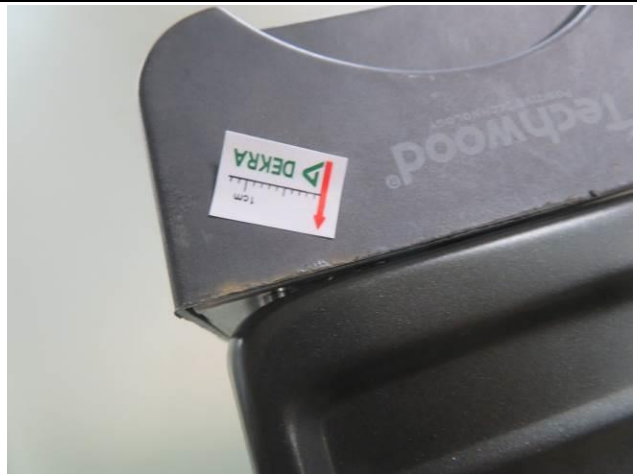
| - Dirty stain on product. | | | | | 1 |

102) Minor - Dirty stain on product
